PILGRIM NUCLEAR POWER STATION REGULATORY CONFERENCE

EDG A Cooling Fan Right Angle Drive Gearbox

July 13, 2017

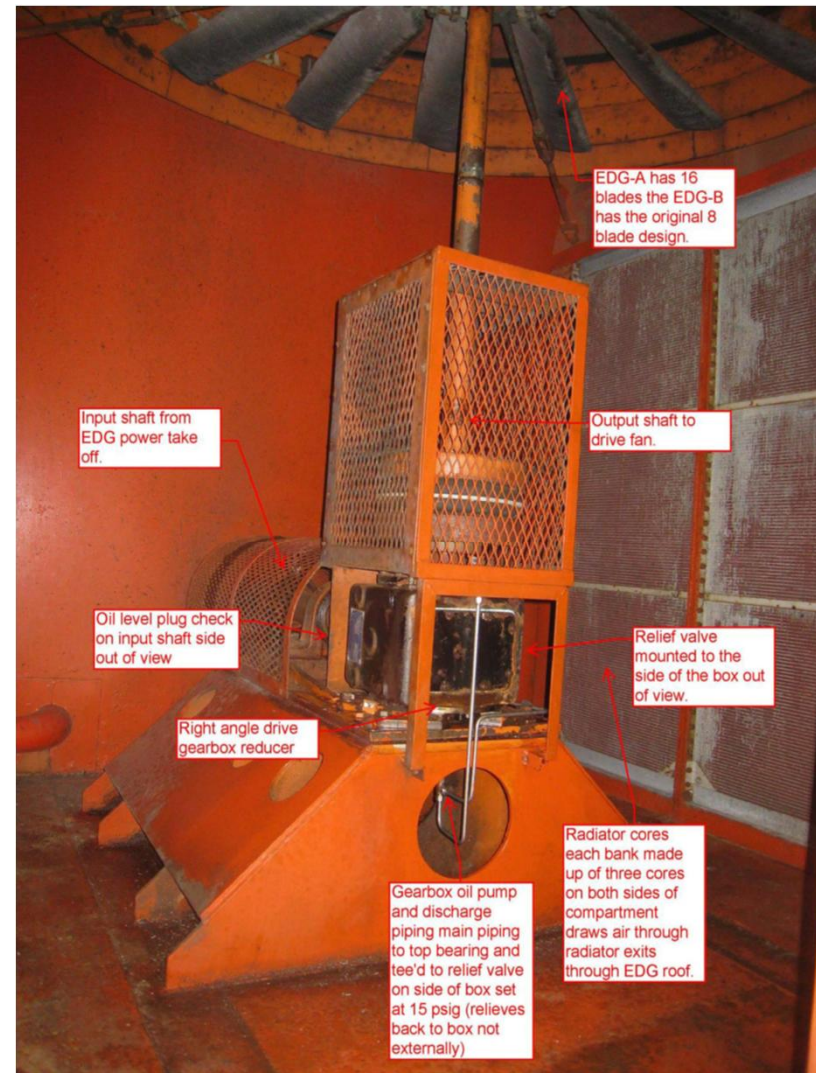
Introduction

- As-found Condition
- Actual picture of EDG-A cooling fan gear box room

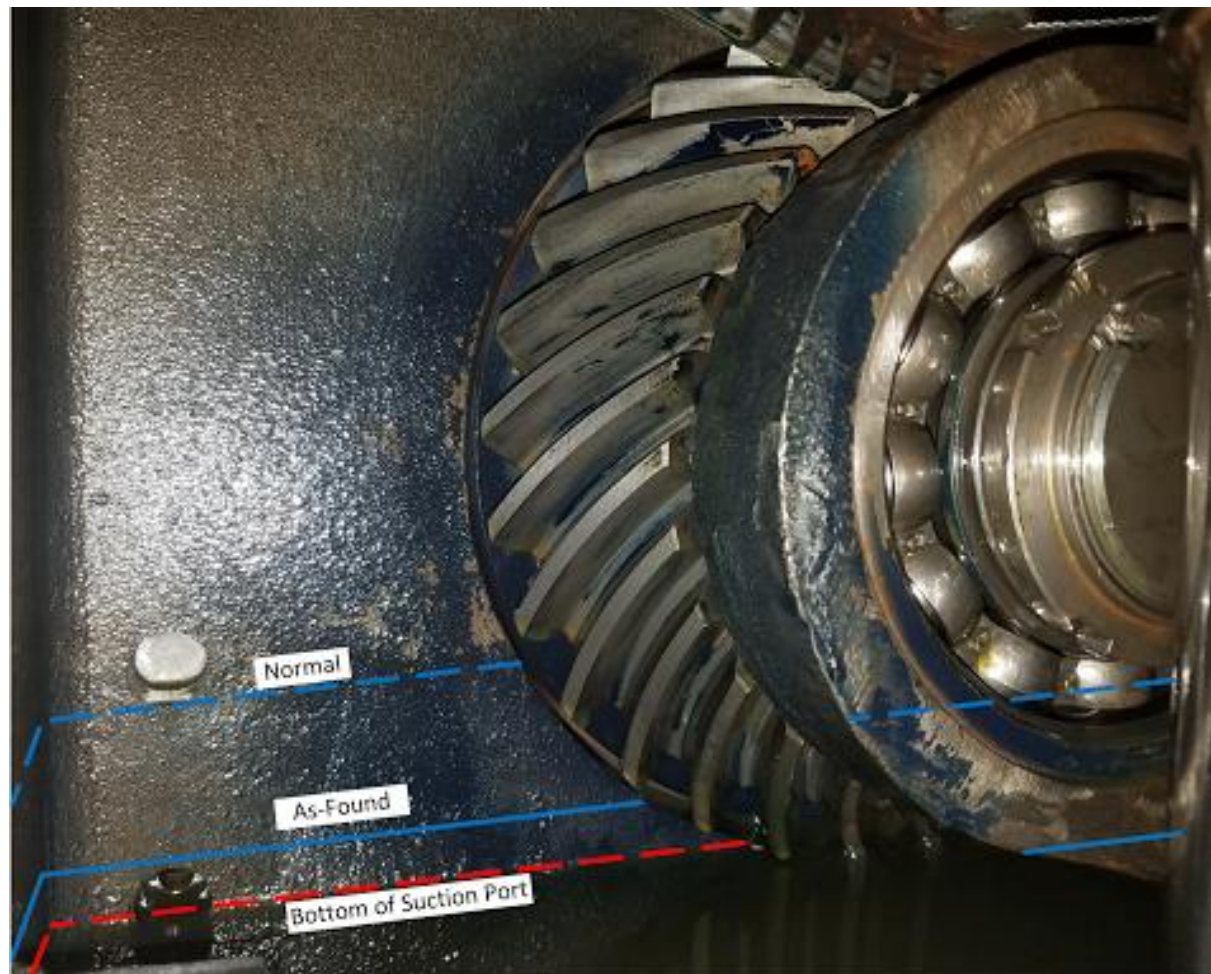
Gearbox Oil Level – Post-Endurance Test

Gear on horizontal shaft always in contact with oil

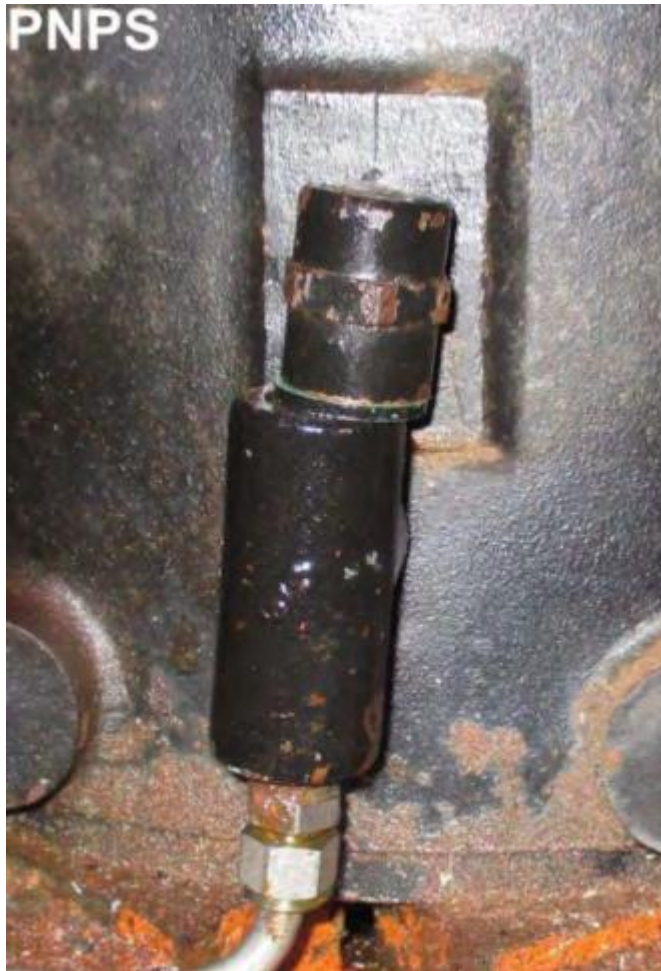
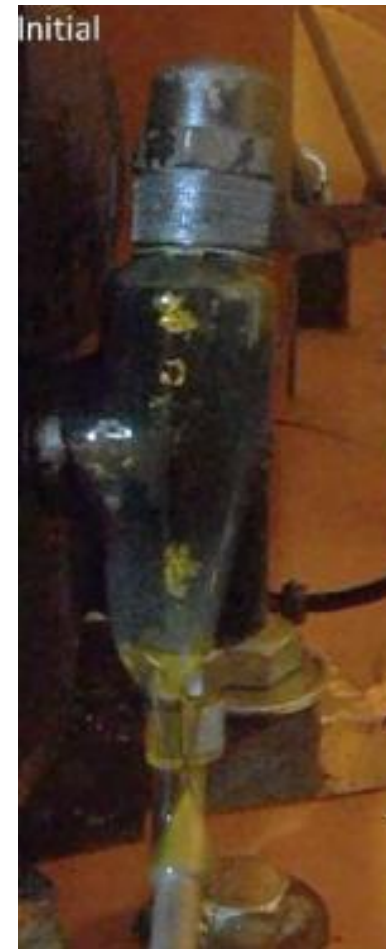
As-Found Condition of Relief Valve

First experience of this in 15 years

- Analytic Approach
 - A calculation evaluated conservative vibration loading to thread pre-load.
 - Determined with the relief valve at normal set pressure, the insert will not back out due to in-plant vibrations.
- Testing Approach
 - A test monitored the movement of the valve insert and cap under vibrations.
 - Determined with the relief valve at normal set pressure, the insert will not back out due to in-plant vibrations.
 - Determined that the as-found relief valve insert and cap position did not result from in-plant vibrations.

- On September 28, 2016, after identifying the low oil condition:
 - Drained oil and internally inspected gearbox visually; with no damage identified.
 - Reassembled, bench tested and set the relief valve at 15 psig and refilled the gearbox with new oil. The monthly Surveillance Test was then successfully completed.
- Pre-start check procedure changed to provide additional guidance on how to validate the gearbox oil level.
- Non-licensed operator trained on gearbox oil level validation method.

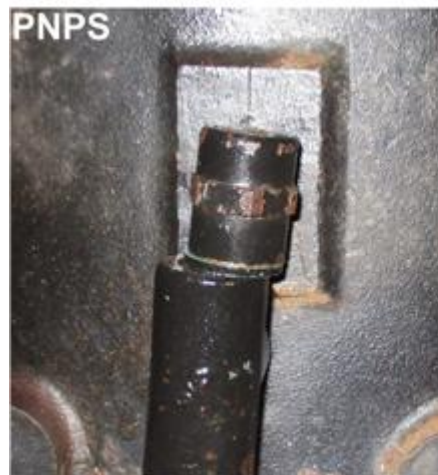
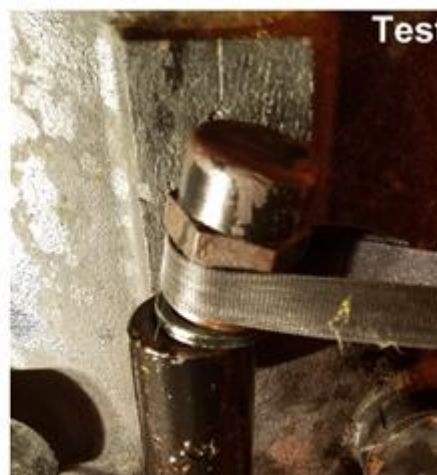
Endurance Test Conditions

- Air temperature bounded possible plant conditions. The temperature was determined for:
 - Highest ambient temperatures recorded on site between August 31 to September 28, 2016
 - Highest accident scenario (LOCA) engine loading
- Relief valve was offset in the as-reported as-found condition, and restrained to bound any condition that could occur.

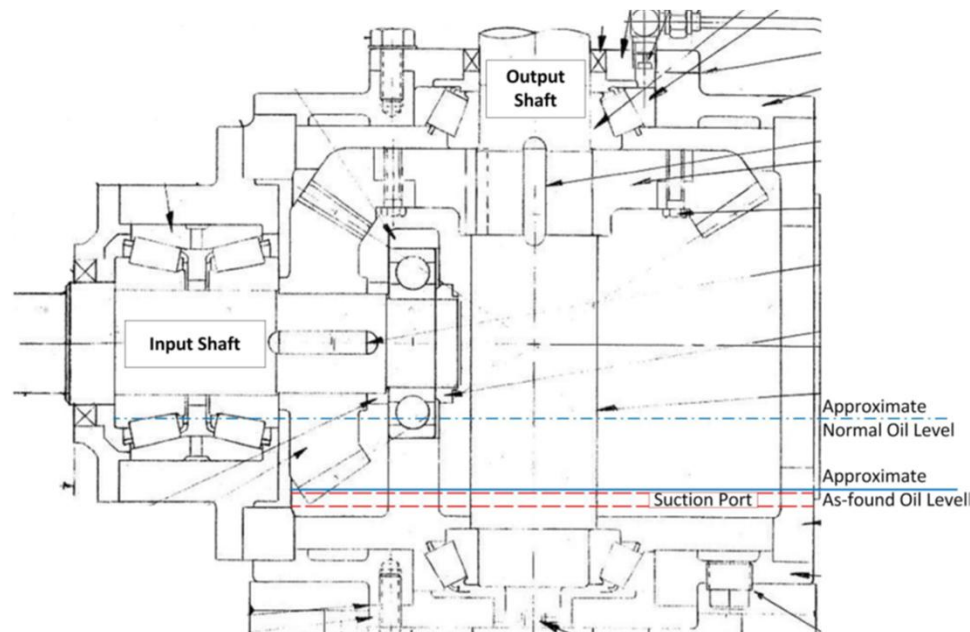
Endurance Test Conditions

- The initial oil level was at the as-found level observed by the maintenance technicians.
 - Allowed the oil to drain undisturbed for 48 hours prior to testing.
 - Level was well below input shaft bearings.

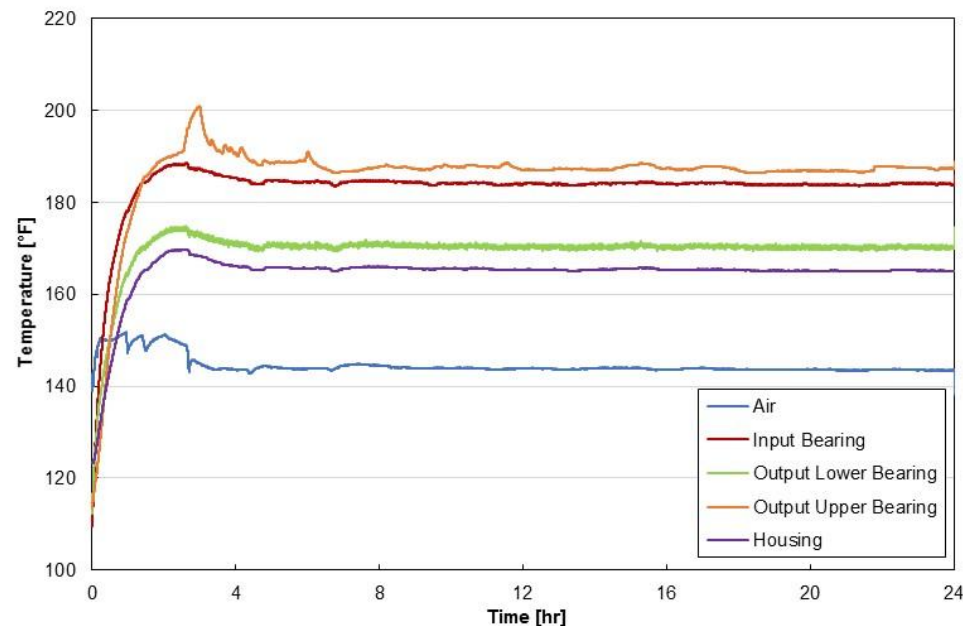
Endurance Test Temperature Results

Temperatures remained well below the 300 F limit

- The gearbox successfully performed its function of transmitting power to the fan for 24 hours with low oil.
- Gearbox temperatures reached steady-state values well below manufacturer's damage threshold limits.

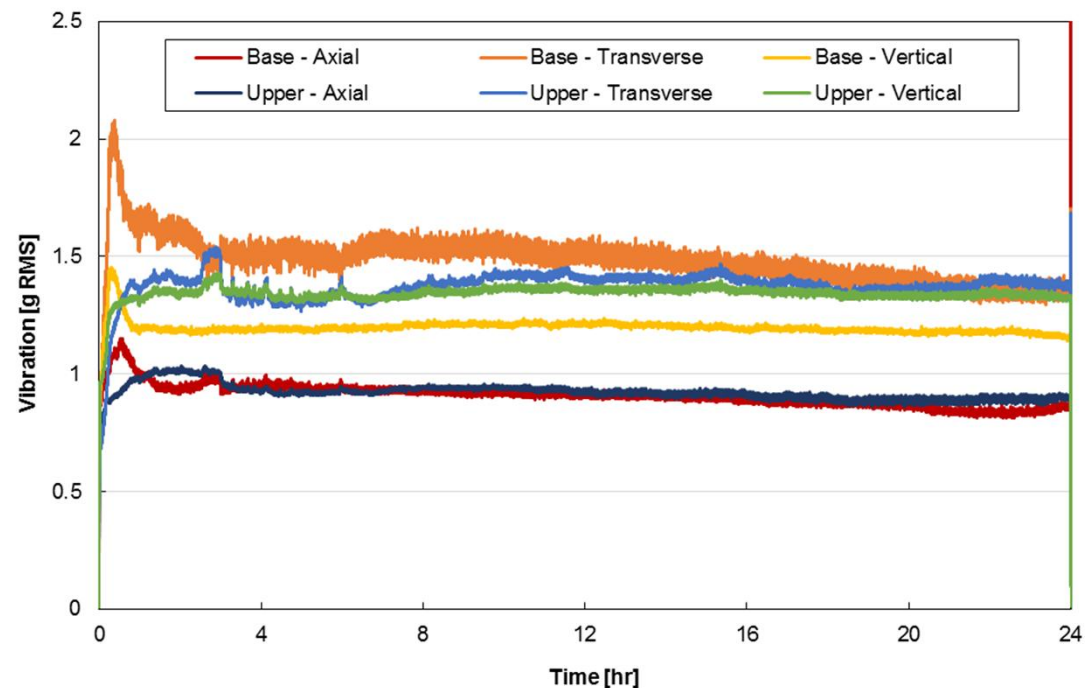
Endurance Test Vibration Results

- The gearbox vendor stated that no increase in vibration indicates no equipment degradation
- Gearbox vibrations reached steady state values during testing in acceptable range

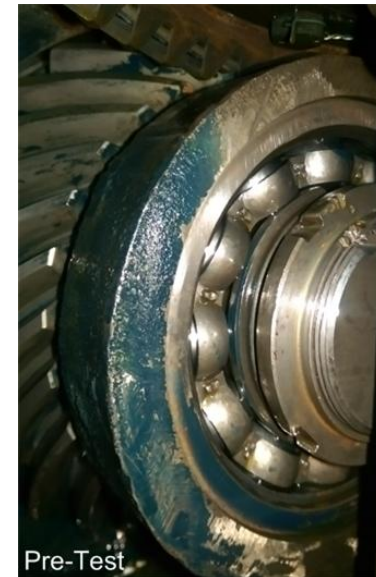
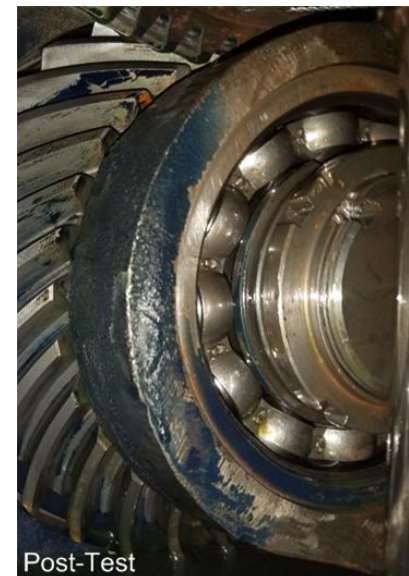
Endurance Test Results

- Demonstrated sustainable operation
- Post-test internal inspections showed no visible damage to gear teeth or the roller bearings.
- Gearbox backlash measurements essentially the same before and after testing
- Oil analysis found indicators of small wear particles
 - Less than 5 mils
 - Symptomatic of misalignment
 - The observed wear would not have impacted long term operation.
